INSTALLATION RESTORATION PROGRAM

Final

SITE INVESTIGATION REPORT VOLUME I

152nd TACTICAL RECONNAISSANCE GROUP NEVADA AIR NATIONAL GUARD RENO CANNON INTERNATIONAL AIRPORT RENO, NEVADA

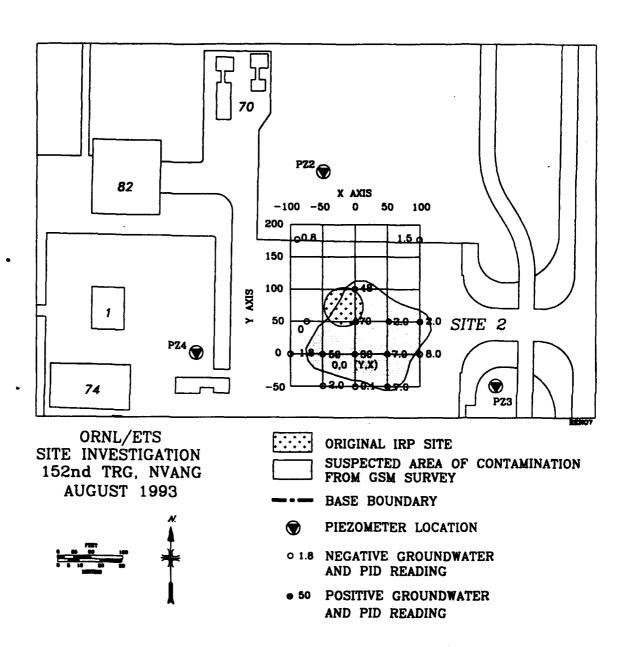
Fig. 5.8. Site 2 GSM survey locations.

Although the GSM survey suggested the trace presence of several chlorinated and fuel-related compounds in the groundwater (TCE, 1,2-DCE, 1,1-DCE, benzene, toluene, ethylbenzene, and xylenes), the coexistence of numerous unknown compounds interfered with definitive compound identification during GC headspace analysis. As previously discussed in Sect. 4.5.1, the GC data were used as a measure of relative contamination. Points with little or no apparent groundwater contamination were deemed negative, and those with moderate to high apparent groundwater contamination were classified positive. Thus, all of the points within the shaded area of Fig. 5.8, which represents the suspected area of groundwater contamination, are positive. Also reported in Fig. 5.8 and Table 5.8

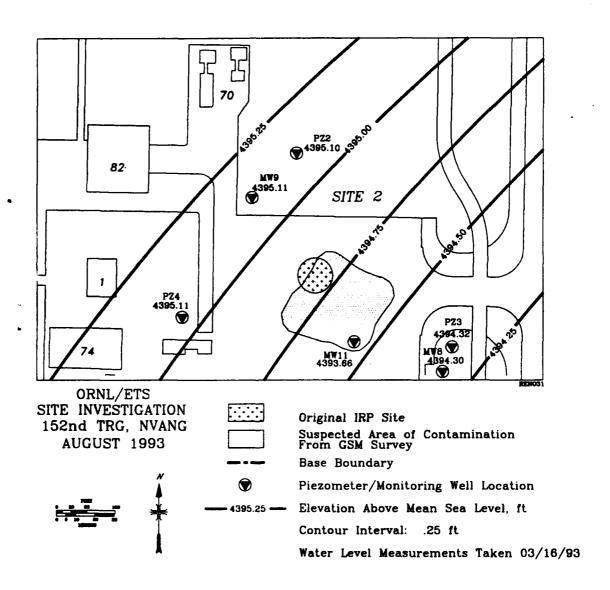
Fig. 5.9. Potentiometric surface for Site 2.

Three piezometers (PZ02, PZ03, and PZ04) were installed around Site 2 in order to determine the optimum placement of downgradient monitoring wells. Construction records for the piezometers are presented in Appendix B. The potentiometric surface map for Site 2 (Fig. 5.9) indicates that groundwater flows to the southeast. Groundwater flow direction is discussed in Sect. 5.4.3.

Results of the groundwater samples and groundwater levels indicate that MW11 may be located outside (south) of the contaminated groundwater flow path affecting MW08. While MW11 has no observed contamination, MW08 located downgradient shows low levels of TCE and 1-2,DCE. The groundwater flow direction indicated by the potentiometric map (Fig. 5.9) also suggests that MW11 is located south of the flow path containing the solvent-contaminated groundwater. Although the respective maximum concentration limits (MCLs) for TCE were exceeded on separate occasions, this contamination is located downgradient of the site and may result from activities not associated with Site 2. Currently Site 2 has been incorporated into Site 12 (Apron Area) which is undergoing investigation. Results of the investigation may provide sufficient information to delineate the contamination contribution from Site 2.

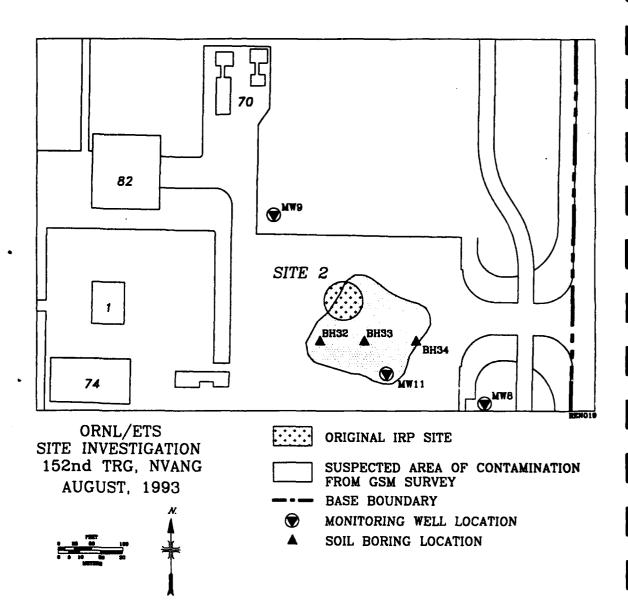
Fig. 5.10. Site 2 soil-boring and monitoring well locations.

None of the inorganic compounds presented in Table 5.10 exceed any of the applicable standards presented in Table 5.7.

Site 2, FTA No. 2: no soil or groundwater contamination above standards was found. Prepare a no-further-action decision document for soils. Install an additional monitoring well downgradient of the site to confirm the origin of observed downgradient contamination and to support a no-further-action decision document for groundwater.

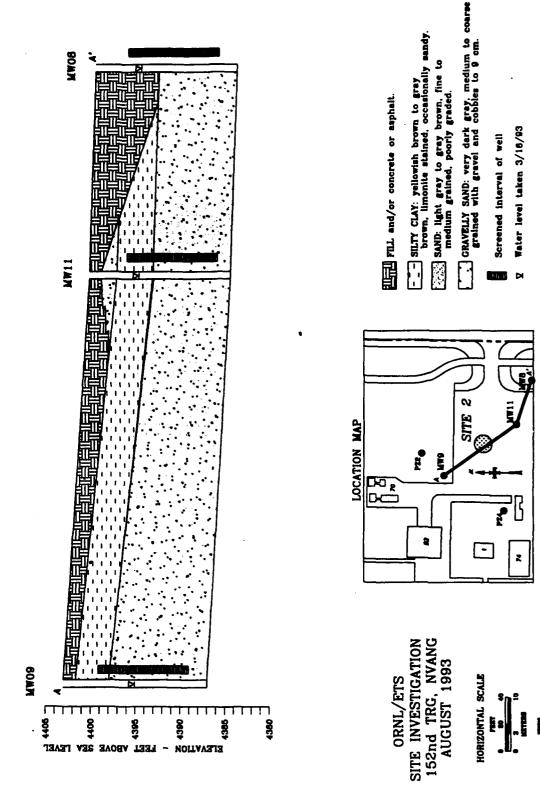
Fig. 5.11. Geologic cross section of Site 2.

The subsurface encountered at Site 2 is comprised of fill material: yellowish-brown to gray silty clay; and very dark gray, well-graded sandy gravel with occasional cobbles. The geologic cross section presented in Fig. 5.11 was constructed using lithologic data from MW08, MW09, and MW11. Well construction data are presented in Appendix B.

The fill material, which thickens from 2 ft at the northwest end to 10 ft at the southeast end, is present across the entire site. The underlying silty clay is approximately 4 ft thick across most the site but pinches out at the southeast end. Thickness of the waterbearing well-graded sand was not determined because none of the monitoring wells penetrate through it completely.

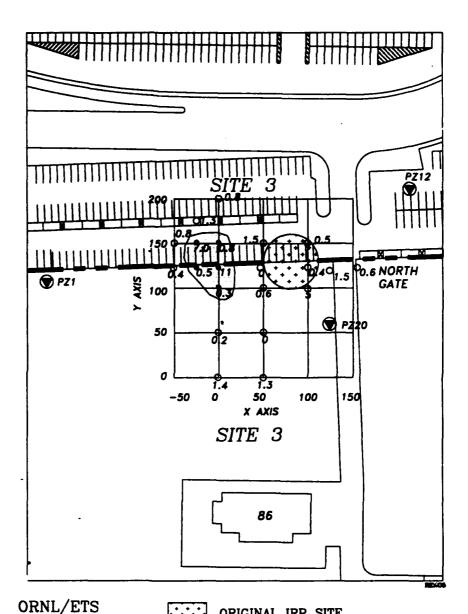
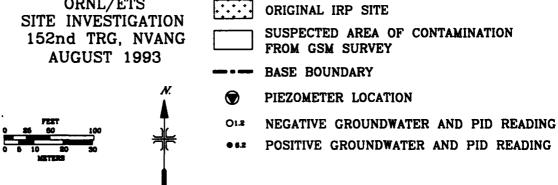
Fig. 5.12. Site 3 GSM survey locations.

The results of the GSM survey are presented in Fig. 5.12 and Table 5.13. Samples were collected from 21 locations on a 200×200 -ft grid with 50-ft spacing. The grid was located to surround the suspected location of the former FTA identified in aerial photographs.

Although the GSM survey suggested trace levels of several chlorinated and fuelrelated compounds in the groundwater (TCE, 1,2-DCE, benzene, and toluene), the coexistence of numerous unknown compounds interfered with definitive compound identification
during GC headspace analysis. As previously discussed in Sect. 4.5.1, the GC data were
used as a measure of relative contamination. Points with little or no apparent groundwater contamination were deemed negative, and those with moderate to high apparent
groundwater contamination were classified positive. Thus, all of the points within the
suspected contamination area, indicated by shading in Fig. 5.12, are positive. Also reported
in Fig 5.12 and Table 5.13 are the PID values recorded at each hole, which are indicative of
VOCs in soil. Consequently, a positive GC decision may be paired with a relatively low
PID reading suggesting potential groundwater contamination without any associated soil

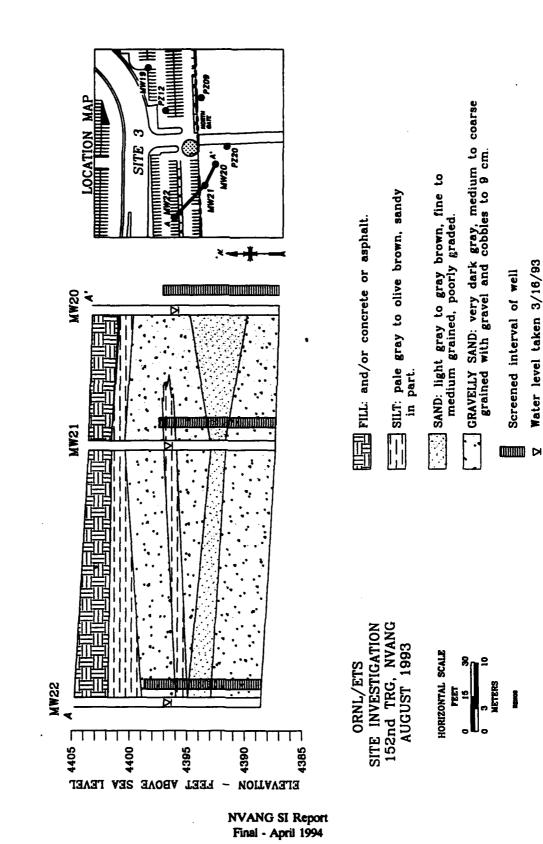
Fig. 5.15. Geologic cross section of Site 3.

The subsurface encountered at Site 3 is comprised of fill material: pale-gray to olive-brown silt; fine to medium-grained, light-gray to gray-brown sand; and very dark gray, well-graded sandy gravel with occasional cobbles. The geologic cross section presented in Fig. 5.15 was constructed using lithologic data from MW20, MW21, and MW22. Well construction data are presented in Appendix B.

Approximately 2 to 3 ft of fill material are present across the entire site. The underlying silt is 2 to 4 ft thick, uniformly calcareous, and increasingly clayey in MW22. Immediately underneath the silt is the well-graded sand, which is divided by a thin silt stringer and a slightly thicker, fine-grained sand stringer. The facies change depicted in the cross section is typical of depositional characteristics observed in fluvial and lacustrine environments. Thickness of the water-bearing well-graded sand was not determined because the of monitoring wells penetrate through it completely.

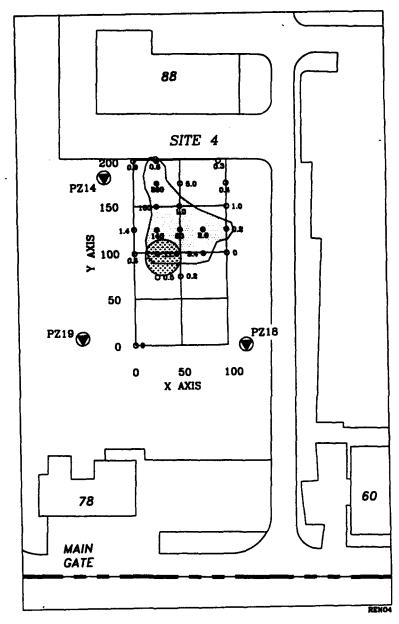
Fig. 5.16. Site 4 GSM survey locations.

The results of the GSM survey are presented in Fig. 5.16 and Table 5.16. Samples were collected from 21 locations on a 100×200 -ft grid with 50-ft spacing. The grid was located to surround the suspected location of the former FTA identified in aerial photographs.

Although the GSM survey suggested the presence of several chlorinated and fuel related compounds in the groundwater (TCE, 1,2-DCE, 1,1-DCE, benzene, toluene, ethylbenzene, and xylenes), the coexistence of numerous unknown compounds interfered with definitive compound identification during GC headspace analysis. As previously discussed in Sect. 4.5.1, the GC data were used as a measure of relative contamination. Points with little or no apparent groundwater contamination were deemed negative, and those with moderate to high apparent groundwater contamination were classified positive. Thus, all of the points within the shaded area of Fig. 5.16, which represents the suspected area of groundwater contamination, are positive. Also reported in Fig. 5.16 and Table 5.16 are the PID readings recorded at each hole, which are indicative of VOCs in the soil. Consequently, a positive GC decision may be paired with a relatively low PID reading, suggesting potential groundwater contamination without any associated soil contamination. Conversely, a relatively high PID reading may be paired with a negative GC decision, suggesting potential soil contamination without any associated groundwater contamination.

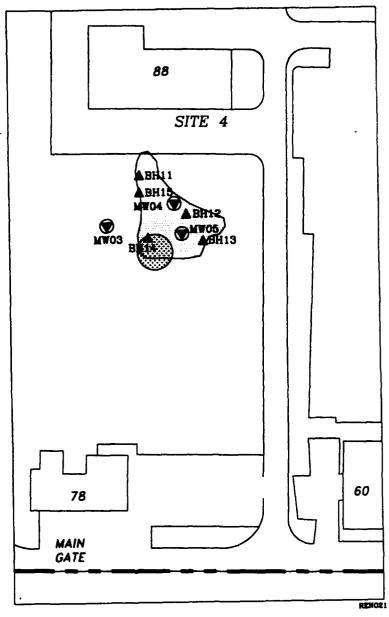
Fig. 5.18. Site 4 soil-boring and monitoring well locations.

As discussed in Sect. 2.2.3, this site consists of a former FTA that has been covered with fill material during the construction of a recreation area. Results of the investigation at Site 4 indicate the presence of significant levels of fuel-related compounds (benzene, ethylbenzene, and xylenes) in the soil. Additionally, significant levels of PHCs reported as TPH were reported in the soil. The highest fuel-related VOC concentrations were found in BH14-8, BH12-8, and BH13-8. PHC concentrations, reported from highest to lowest,

Site 4, FTA No. 4: soil contamination was found. A Remedial Investigation/Feasibility Study (RI/FS) is recommended for this site.

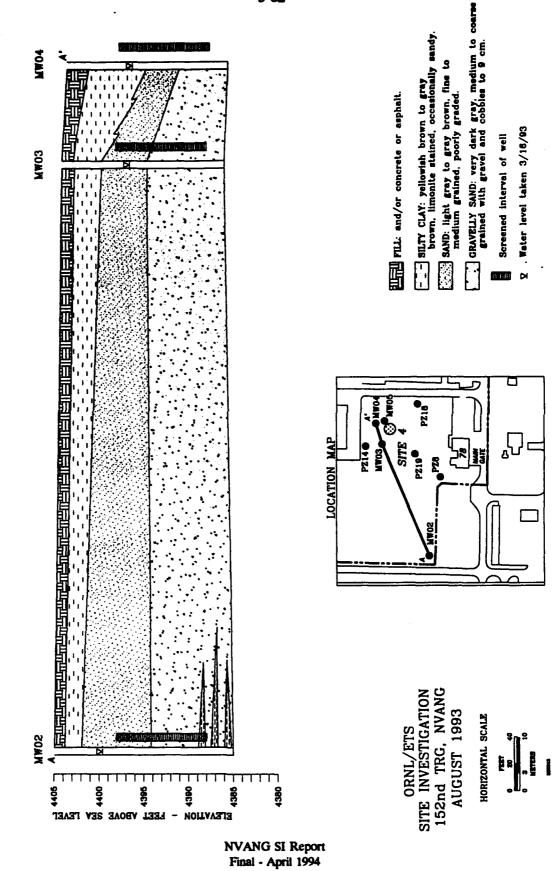
Fig. 5.19. Geologic cross section of Site 4.

were found in BH14-8, BH12-8, BH15-6D, and BH13-8. Although acetone and methylene chloride are reported at significant but estimated levels, their sporadic occurrence is likely related to spurious laboratory contamination rather than actual environmental contamination. Similarly, the sporadic low levels of chloroform and bis(2-ethylhexyl) phthalate are not considered significant for reasons previously discussed.

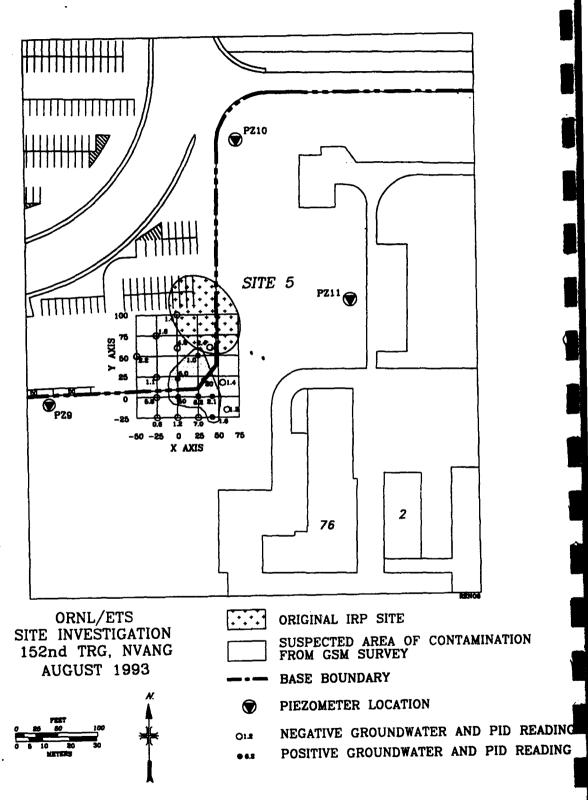
Fig. 5.20. Site 5 GSM survey locations.

The results of the GSM survey are presented in Fig. 5.20 and Table 5.19. Samples were collected from 19 locations on a 125×125 -ft grid with 25-ft spacing. The grid was located to overlie the suspected location of the former FTA identified in aerial photographs.

Although the GSM survey suggested the presence of several chlorinated and fuel related compounds in the groundwater (TCE, 1,2-DCE, 1,1-DCE, benzene, toluene, ethylbenzene, and xylenes), the coexistence of numerous unknown compounds interfered with definitive compound identification during GC headspace analysis. As previously discussed in Sect. 4.5.1, the GC data were used as a measure of relative contamination. Points with little or no apparent groundwater contamination were deemed negative, and those with moderate to high apparent groundwater contamination were classified positive. Thus, all of the points within the shaded area of Fig. 5.20, which represents the suspected area of groundwater contamination, are positive. Also reported in Fig. 5.20 and Table 5.19 are the PID readings recorded at each hole, which are indicative of VOCs in the soil. Consequently, a positive GC decision may be paired with a relatively low PID reading, suggesting potential groundwater contamination without any associated soil contamination. Conversely, a relatively high PID reading may be paired with a negative GC decision, suggesting potential soil contamination without any associated groundwater contamination.

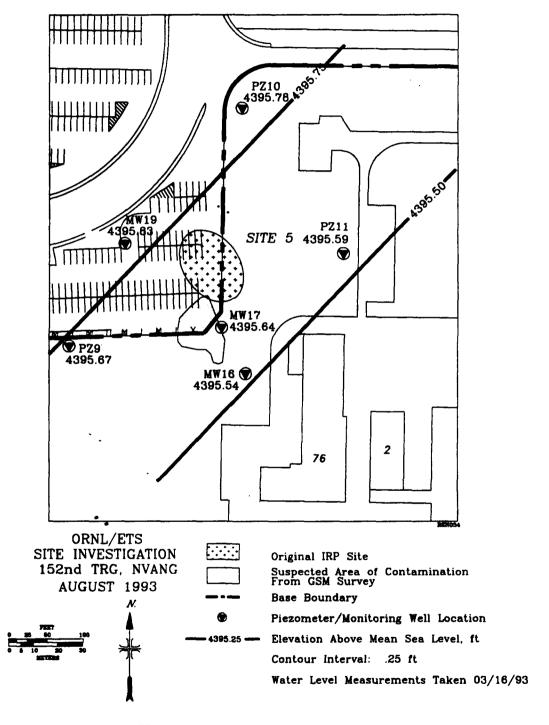
Fig. 5.21. Potentiometric surface for Site 5.

Three piezometers (PZ09, PZ10, and PZ11) were installed around Site 5 in order to determine the optimum placement of downgradient monitoring wells. Construction data on the piezometers are presented in Appendix B. The potentiometric surface map for Site 5 (Fig. 5.21) indicates that groundwater flows to the southeast. Groundwater flow direction is discussed in Sect. 5.7.3.

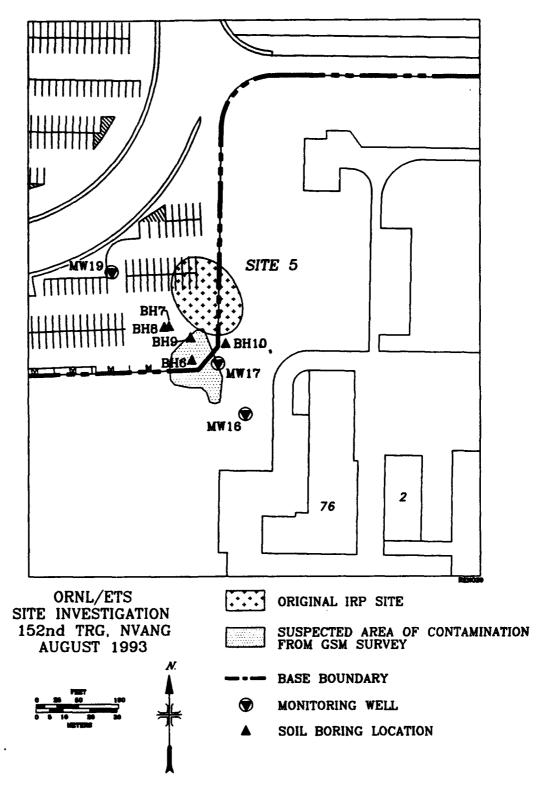
Fig. 5.22. Site 5 soil-boring and monitoring well locations.

PHCs reported as TPH were found in samples from both rounds from MW17 at levels ranging from 0.10 to 0.15 mg/L.

As discussed in Sect. 2.2.4, this site consists of a former FTA that has been covered with fill material during the expansion of a parking area north of the Base. Results of the investigation at Site 5 indicate the presence of significant levels of fuel-related compounds (ethylbenzene and xylenes) in the soil. Additionally, significant levels of PHCs reported as

Site 5, FTA No. 5: soil contamination was found. An RI/FS is recommended for this site.

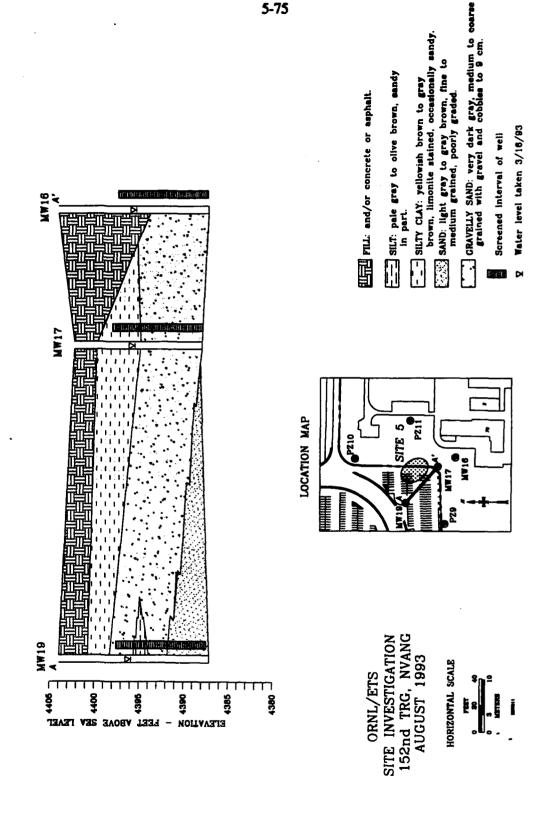
Fig. 5.23. Geologic cross section of Site 5.

cobbles and pale-gray to olive-brown sandy silt streaks. The geologic cross section presented in Fig. 5.23 was constructed using lithologic data from MW16, MW17, and MW19. Well construction data are presented in Appendix B.

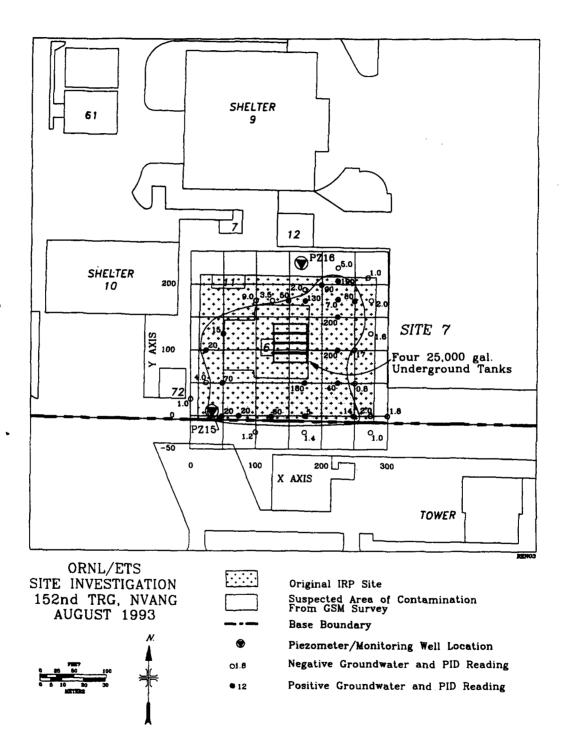
Fig. 5.24. Site 7 GSM survey locations.

The results of the GSM survey are presented in Fig. 5.24 and Table 5.22. Samples were collected from 34 locations on a 300×300 -ft grid with 50-ft spacing. The grid was laid over the Site 7 area.

Although the GSM survey suggested the presence of several chlorinated and fuel related compounds in the groundwater (TCE, 1,2-DCE, 1,1-DCE, benzene, toluene, ethylbenzene, and xylenes), the coexistence of numerous unknown compounds interfered with definitive compound identification during GC headspace analysis. As previously discussed in Sect. 4.5.1, the GC data were used as a measure of relative contamination. Points with little or no apparent groundwater contamination were deemed negative, and those with moderate to high apparent groundwater contamination were classified positive. Thus, all of the points within the shaded area of Fig. 5.24, which represents the suspected area of groundwater contamination, are positive. Also reported in Fig. 5.24 and Table 5.22, are the PID readings recorded at each hole, which are indicative of VOCs in the soil. Consequently, a positive GC decision may be paired with a relatively low PID reading, suggesting potential groundwater contamination without any associated soil contamination. Conversely, a relatively high PID reading may be paired with a negative GC decision, suggesting potential soil contamination without any associated groundwater contamination.

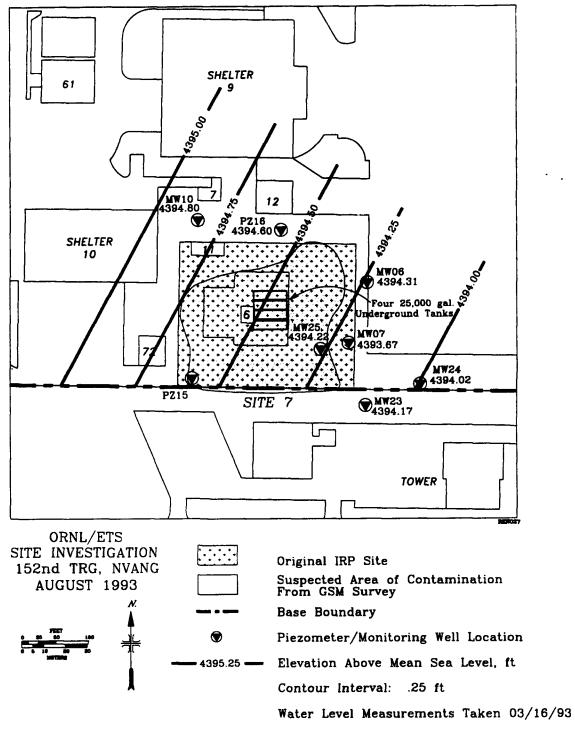
Fig. 5.25. Potentiometric surface for Site 7.

Two piezometers (PZ15 and PZ16) installed around Site 7 were used in conjunction with one of the base wide piezometers (PZ05 in Fig. 5.6) to determine the optimum placement of monitoring wells. Construction data on the piezometers are presented in Appendix B. The potentiometric surface map for Site 7 (Fig. 5.25) indicates that groundwater flows to the southeast. Groundwater flow direction is discussed in Sect. 5.8.3.

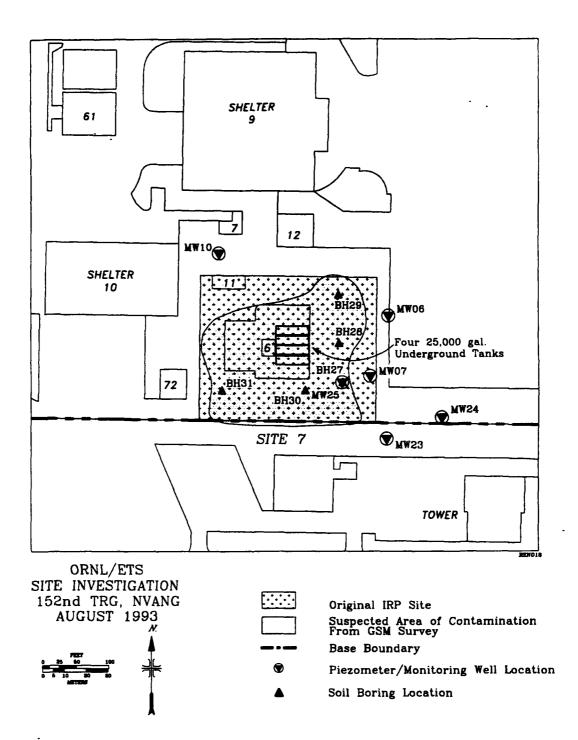
Fig. 5.26. Site 7 soil-boring and monitoring well locations.

As discussed in Sect. 2.2.5, this site consists of a POL storage area. Results of the investigation at Site 7 indicate the presence of significant levels of fuel-related compounds

Site 7, Petroleum, Oil, and Lubricants Storage Facility: soil contamination was found. An RI/FS is recommended for this site.

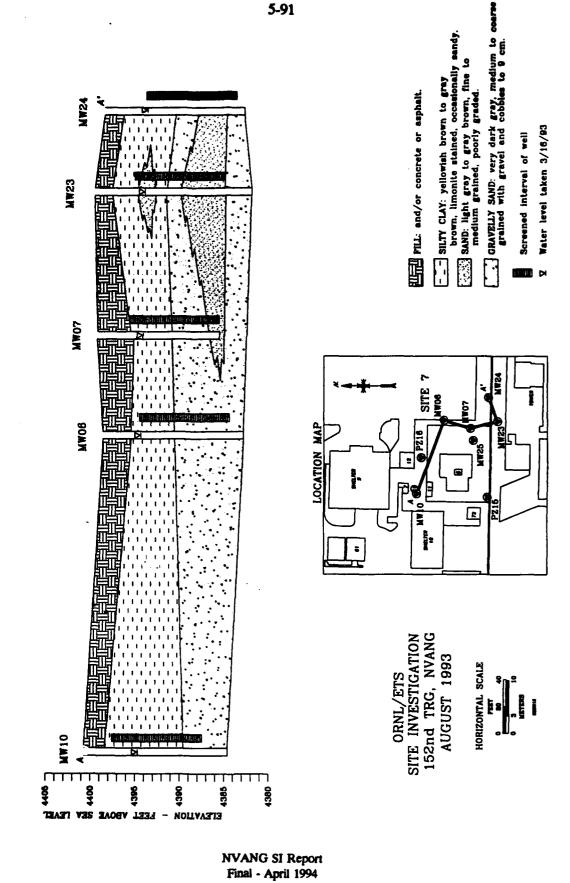
Fig. 5.27. Geologic cross section of Site 7.

grained poorly graded sand; and very dark gray, well-graded sandy gravel with occasional cobbles. The geologic cross section presented in Fig. 5.27 was constructed using lithologic data from MW10, MW06, MW07, MW23, and MW24. Well construction data are presented in Appendix B.

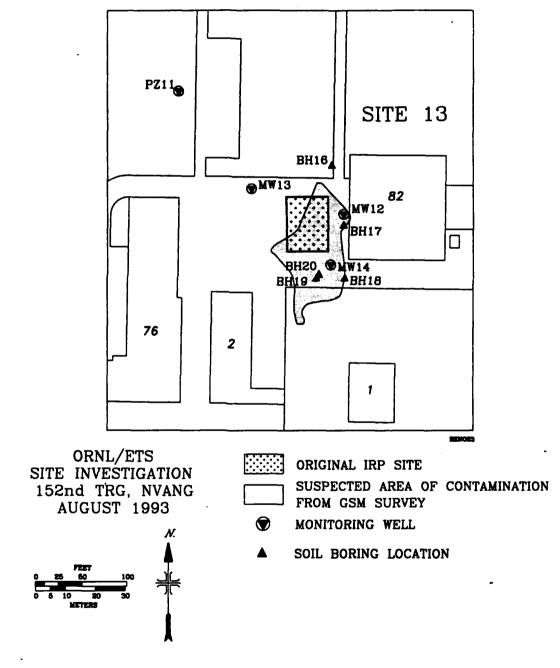
Fig. 5.30. Site 13 soil-boring and monitoring well locations.

Two VOCs were detected in the soil at Site 13. These compounds include chloroform (1.0 μ g/kg, J) and 2-butanone (16 μ g/kg).

Site 13, Storm Drains at the Aerospace Ground Equipment Storage Yard: no soil or groundwater contamination above standards was found. Prepare a no-further-action decision document.

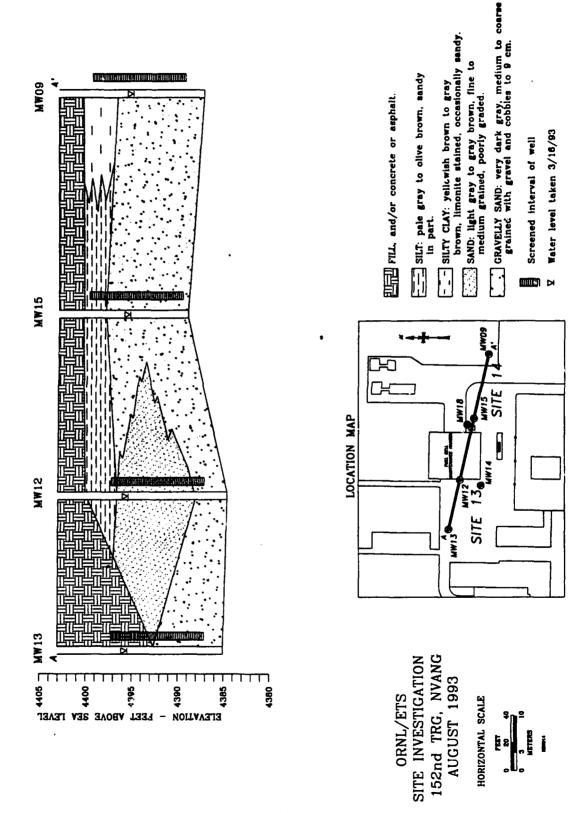
Fig. 5.31. Geologic cross section of Sites 13 and 14.

The subsurface lithology for Sites 13 and 14 is discussed jointly due to their relative proximity to one another and lithologic similarity. The subsurface at Sites 13 and 14 is comprised of fill material: pale-gray to olive-brown sandy silt, yellowish-brown to gray-brown silty clay with occasional sand; light-gray to gray-brown, fine to medium-grained, poorly graded sand; and very dark gray, well-graded sandy gravel with occasional cobbles. The geologic cross section presented in Fig. 5.31 was constructed using lithologic data from MW13, MW12, MW15, and MW09. Well construction data are presented in Appendix B.

Approximately 3 ft of fill material are present across Sites 13 and 14 with the exception of MW13, which has about 10 ft. The underlying silty clay reaches a maximum thickness of about 4 ft and grades into sandy silt between MW15 and MW09. Generally, the silt and silty clay are underlain by well-graded sandy gravel that contains a lens of poorly graded sand on the west end of the cross section. Actual thickness of the water-bearing, well-graded sand was not determined because none of monitoring wells penetrated through it completely.

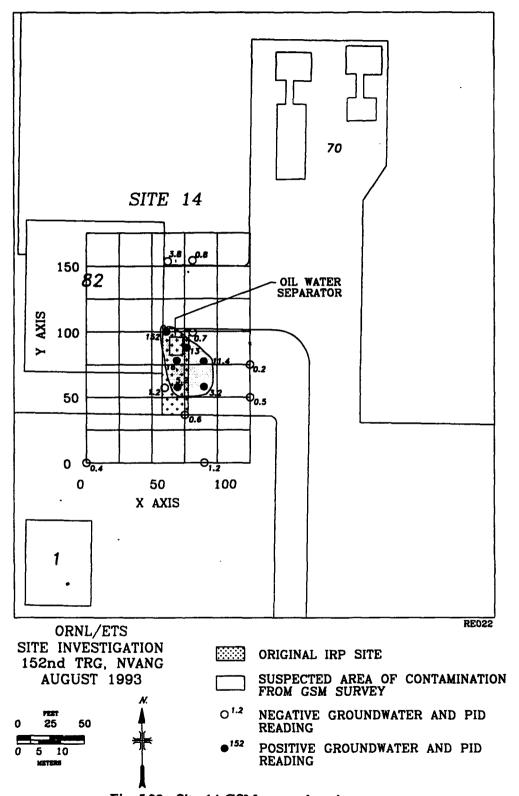
Fig. 5.32. Site 14 GSM survey locations.

The results of the GSM survey are presented in Fig. 5.32 and Table 5.29. Samples were collected from 15 locations on a 125×175 -ft grid with 25-ft spacing. The grid was laid over the area suspected to have received overflows from the OWS.

Although the GSM survey suggested the trace presence of fuel-related compounds in the groundwater (benzene, toluene, ethylbenzene, and xylenes), the coexistence of numerous unknown compounds interfered with definitive compound identification during GC headspace analysis. As previously discussed in Sect. 4.5.1, the GC data were used as a measure of relative contamination. Points with little or no apparent groundwater contamination were deemed negative, and those with moderate to high apparent groundwater contamination were classified positive. Thus, all of the points within the shaded area (Fig. 5.32), which represents the suspected area of groundwater contamination, are positive. Also reported in Fig. 5.32 and Table 5.29 are the PID readings recorded at each hole, which are indicative of VOCs in the soil. Consequently, a positive GC decision may be paired with a relatively low PID reading, suggesting potential groundwater contamination without any associated soil contamination. Conversely, a relatively high PID reading may be paired with a negative GC decision, suggesting potential soil contamination without any associated groundwater contamination.

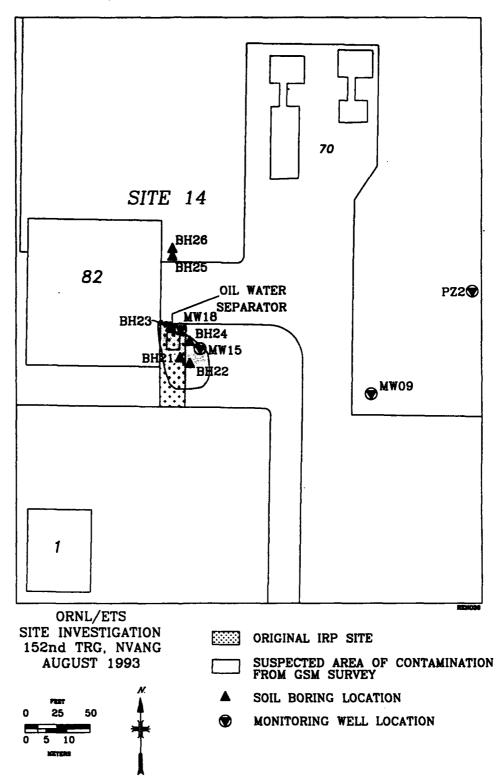
Fig. 5.33. Site 14 soil-boring and monitoring well locations.

PHCs, reported as TPH, ranged from 0.11 to 4800 mg/kg at Site 14.

Groundwater samples were collected in December 1992 and March 1993 from the wells shown in Fig. 5.33. Complete analytical results are presented in Table D-1 of Appendix D. Significant groundwater data from Site 14 are presented in Table 5.31. Field measurements made during sampling are presented in Tables 5.11 and 5.12.
